# Manhole Inspection Summary

Manhole # S39C2\_030MH

Insp Date: **12/26/07 1:36 PM**

**Location** Address: **4208 5th St**

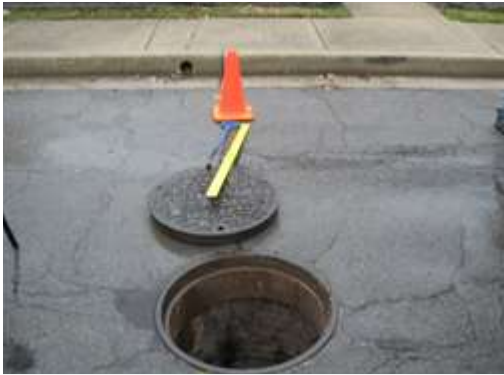
Location View

4208 5th St

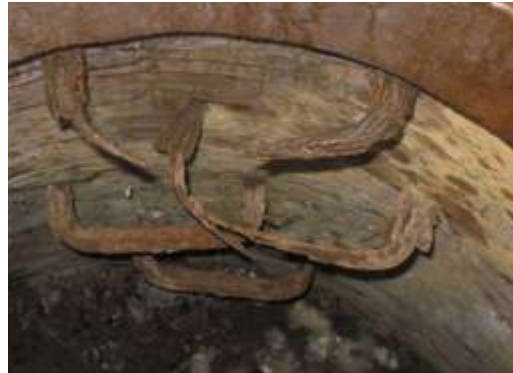
Defect 1

Count: **2** Missing: **2** ☒ **Corroded**

broken/missing steps

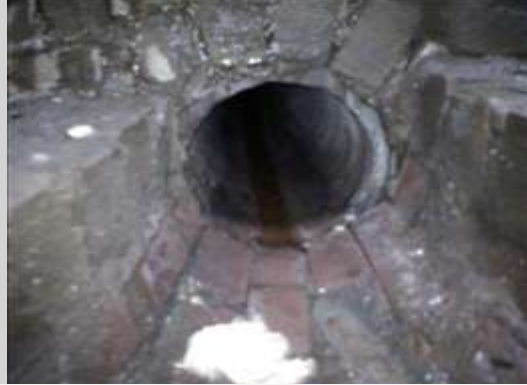
12 O'Clock Outflow

8 in. Circular Gravity Sewer  
Pipe Out @ 12 O'Clock

Pipe Height: **8.4** (in.) Rod and Bar (Angled)  
Pipe Material: **Clay** ☐ Pipe Lined  
Invert Depth: **7.96** (ft.) Flow Characteristics: **None**  
Deposits: ☒ None ☐ Mud ☐ Sludge ☐ Debris ☐ Grease  
Silt Depth: (in.) Deposits Extent:  
Infiltration: **None** Pipe Seal Cond: **Sound**

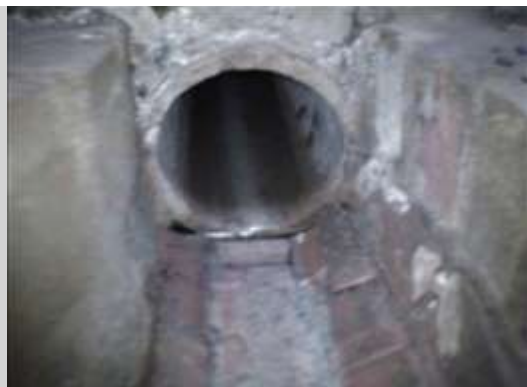
5 O'Clock Inflow

6 in. Circular Service Sewer  
Pipe In @ 5 O'Clock

Pipe Height: **7.2** (in.) Rod and Bar (Angled)  
Pipe Material: **Clay** ☐ Pipe Lined  
Invert Depth: **7.68** (ft.) Flow Characteristics: **None**  
Deposits: ☒ None ☐ Mud ☐ Sludge ☐ Debris ☐ Grease  
Silt Depth: (in.) Deposits Extent:  
Infiltration: **None** Pipe Seal Cond: **Sound**

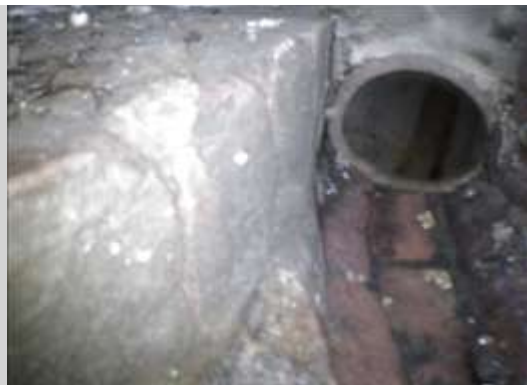
7 O'Clock Inflow

6 in. Circular Service Sewer  
Pipe In @ 7 O'Clock

Pipe Seal Cond: **Sound**
